FIELD INSPECTION

Project Name:	Mountain Valley Pipeline	Inspector:	Matthew Grant
Inspection Date:	Thursday, October 31, 2019	Project Contact:	Brian Clauto
Spread: Montgomery Co. ATWS 703, 704A 1375, 1446 MP230.4-230.9 MN-274 MN-275	Spread H	Weather (Wet/Dry/Rain):	Rainy

FIELD INSPECTION PHOTO LOG

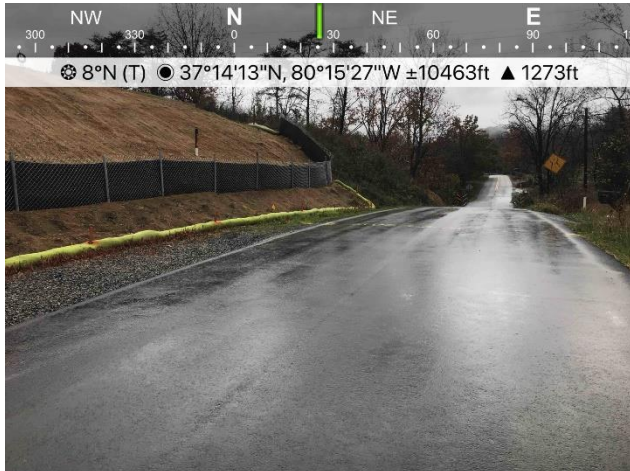
- Fig. 1 Near MP 231.09 Bradshaw Rd crossing, ECD's in place and functioning.

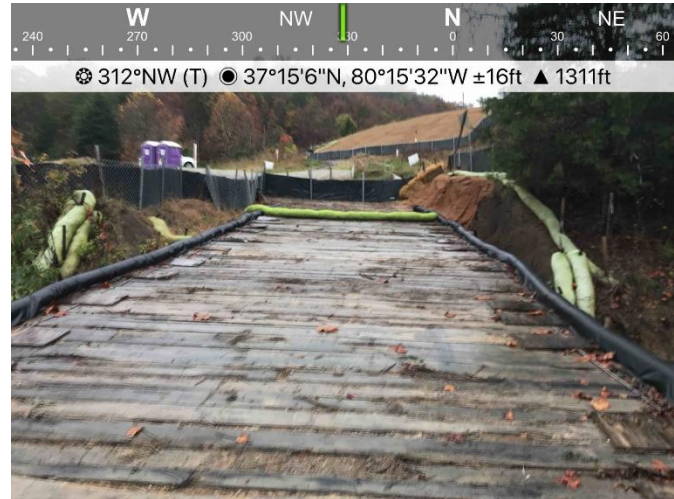
- Fig. 2 Designated stream crossing S-C21, ECD's in place and functioning.

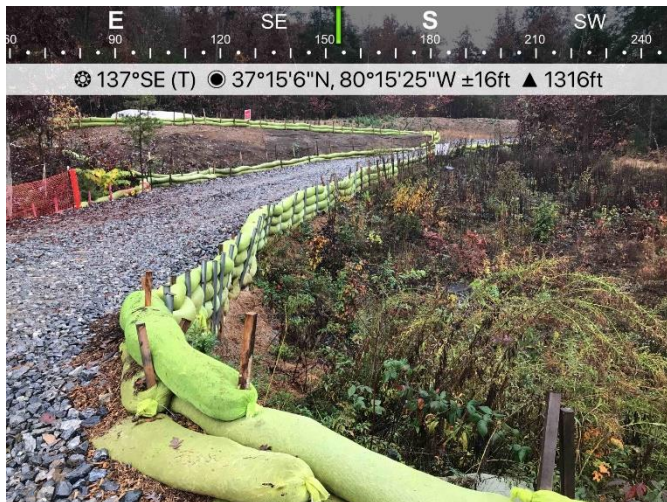
- Fig. 3 On MN-275 above designated stream S-001 ECD's were in place and functioning.

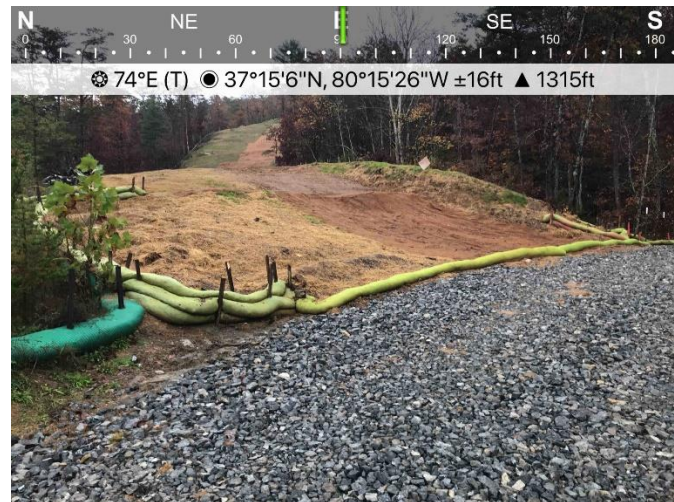
- Fig. Near St1220+00 at MN-275 ECD's are in place and functioning.
